BUILDING SCIENCE SERIES 44

Full Scale Test on a Two-Story House Subjected to Lateral Load

Felix Y. Yokel, George Hsi, and
Norman F. Somes

Tests were carried out on a single-family, detached house to determine its deflection characteristics under lateral loads. The house was a two-story building of conventional wood-frame construction. Two series of tests were conducted. The first of these was to determine the stiffness of the house when subjected to a simulation of wind loading. The second was to determine the dynamic response of the house to a single impulse load.

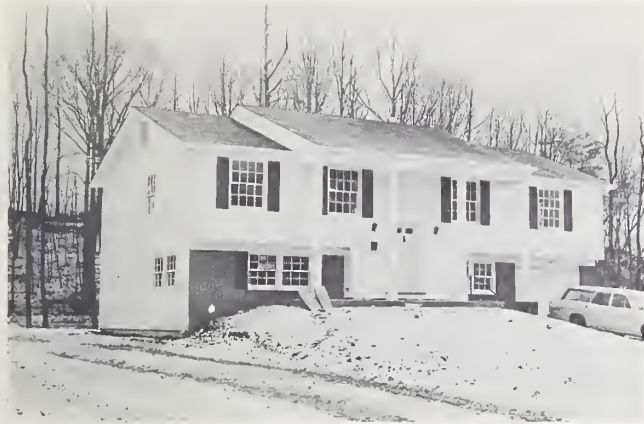
FIGURE 3.1 Front view of the building.

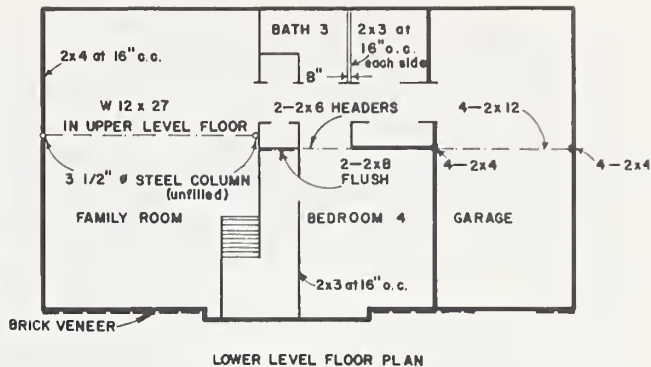
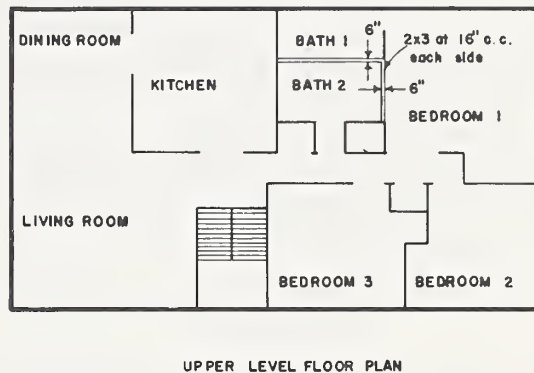
FIGURE 3.2 Floor plans of the building.

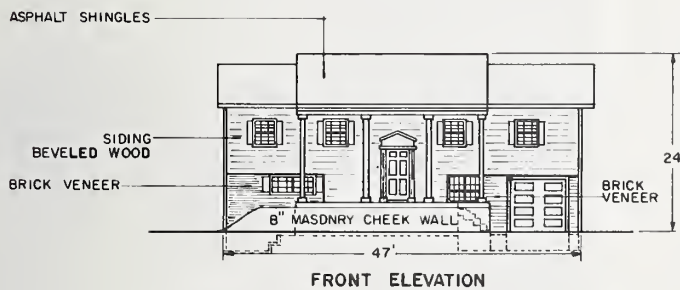
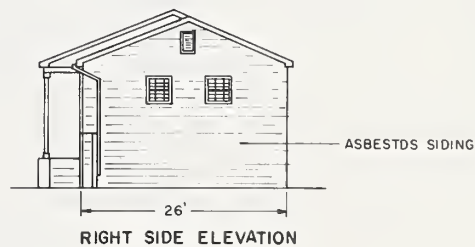
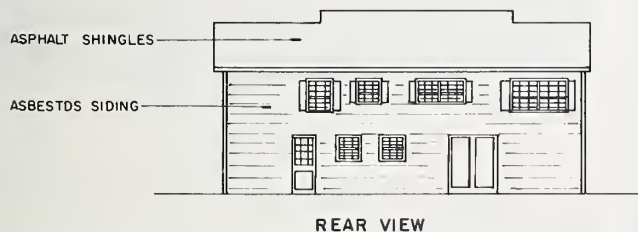
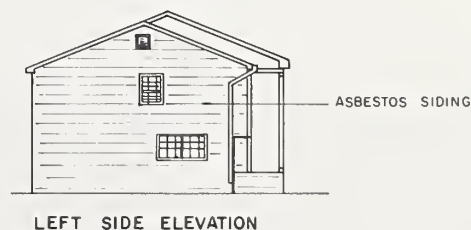
FIGURE 3.3 Elevations of the building.

is tied to the stud wall by galvanized corrugated metal ties, provided in every 7th course and spaced 32 in on center. Exterior-wall studs are braced at all building corners with 1×4 let-in bracing installed at a 45° angle to the horizontal in accordance with the provisions in the FHA Minimum Property Standards [7]. Exterior siding is asbestos shingle or $3/8$ -in-thick beveled wood siding with a 6-in exposure, as shown by the elevations in figure 3.3.

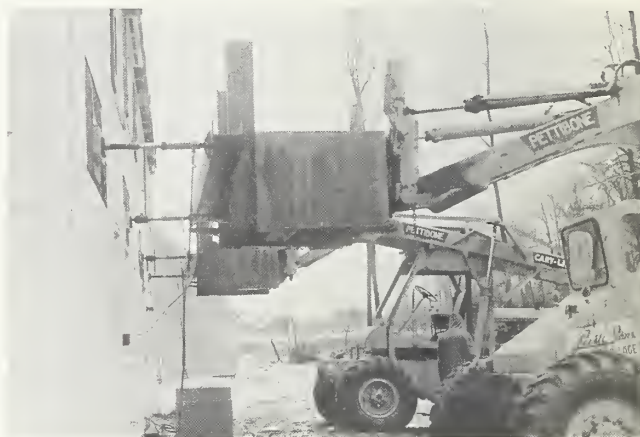
FIGURE 4.1 Loading arrangement.

The loading arrangement is shown in figure 4.1. Two 10-ton forklifts were used to hold the loading assembly in its desired position and to resist the reaction forces. Each forklift carried a 5-kip concrete block to counterbalance the overturning moment caused by the applied horizontal load and to increase frictional resistance to sliding on the ground. A loading assembly was bolted to each concrete block. The assembly consisted of two

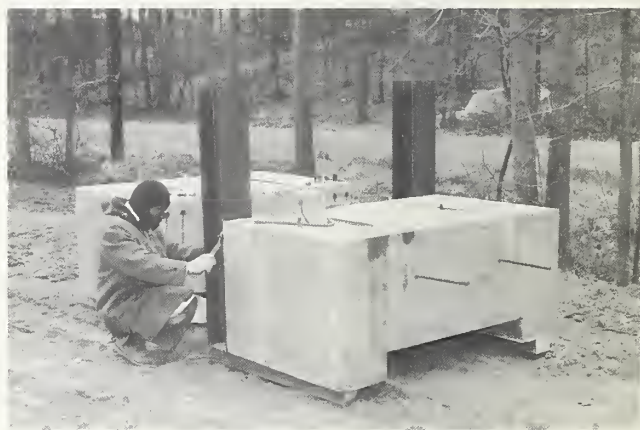
FIGURE 4.2 Mounting of loading assembly.

vertical 5-ft-long $W8 \times 31$ beams⁴ and one horizontal 14-ft-long $W8 \times 31$ beam which supported two rams spaced 12 ft on center. Figure 4.2 shows the concrete blocks during the attachment of the vertical beams. In figure 4.3, a horizontal beam is positioned in its correct location by the forklift. The horizontal beams were attached to the vertical beams by clips which permitted leveling and vertical adjustment of their position. Slotted bolt holes permitted some horizontal adjustment of the positions of these beams; however, in general, the correct horizontal positioning of the rams was achieved by correct positioning of the forklifts.

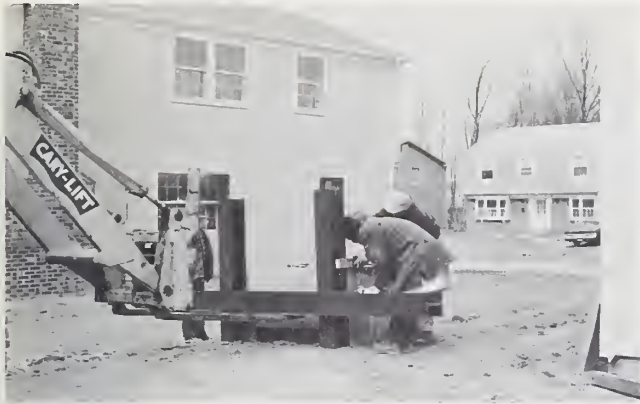
FIGURE 4.3 Positioning of horizontal loading beam.

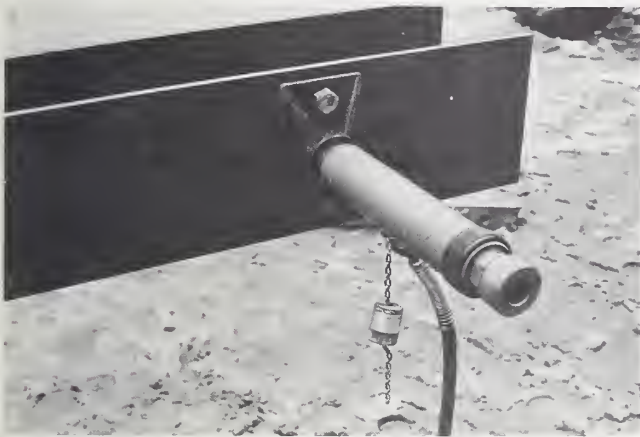
FIGURE 4.4 Loading ram.

Figure 4.4 shows one of the rams carried by a horizontal beam.

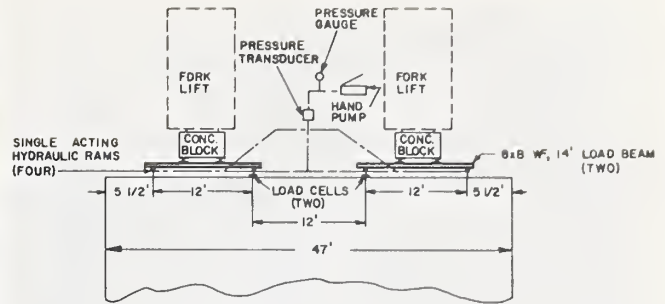
FIGURE 4.5 Loading system.

The loading system and the horizontal position of the loads are shown schematically in figure 4.5. Each of the four single-acting hydraulic rams had a load capacity of

10 tons, a 2-in-diameter piston and a 6-in stroke. Oil pressure was applied by a single hand pump to all four rams through a manifold and hoses arranged in parallel. Load was monitored by two separate and redundant systems: a pressure transducer connected to the hydraulic system; and two load cells, each with an operating range of 5 kip, monitoring two of the ram loads as shown in the figure. Compressive loads were applied to the rear wall of the building. Loads were monitored electronically. Data in this report are referenced to readings of one of the load cells as described in the appendix.

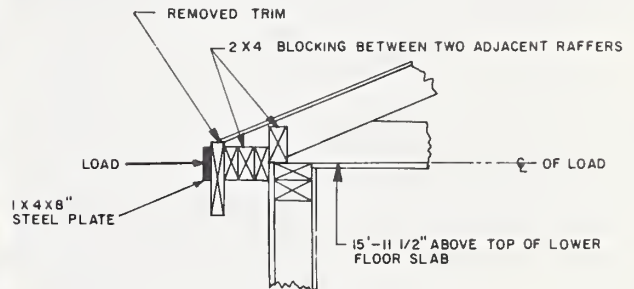
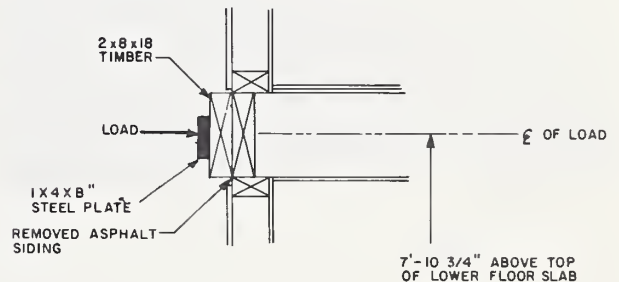
FIGURE 4.6 Load transfer to the building.

The manner of load transfer to the building as well as the vertical positioning of the loads are illustrated in figure 4.6. Load was applied at the underside of the horizontal roof-truss members and at the level of the

centerline of the second-story floor joists. At the upper level, load was applied through an $8 \times 4 \times 1$ -in steel plate to a 2×8 wood member which in turn transferred the load to 2×4 members nailed between two successive roof trusses. This method of load transfer was chosen to prevent local load concentrations and accompanying permanent damage and also to minimize the removal of siding. At the lower level, load was applied through an $8 \times 4 \times 1$ -in steel plate to a 2×8 wood member which in turn transferred the load through the rim joist to the floor joists.

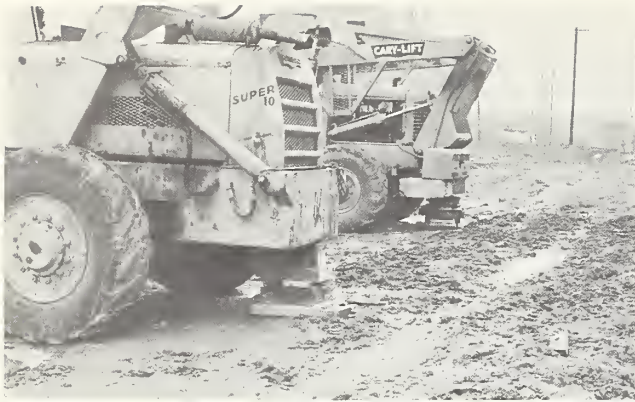
FIGURE 4.7 Reaction blocks at rear of forklift.

the friction force on the forklift wheels. Wooden blocking had to be used in the front and the rear of the forklifts to increase lateral load resistance (see figs. 4.7 and 4.8). This arrangement did not affect the accuracy of load positioning.

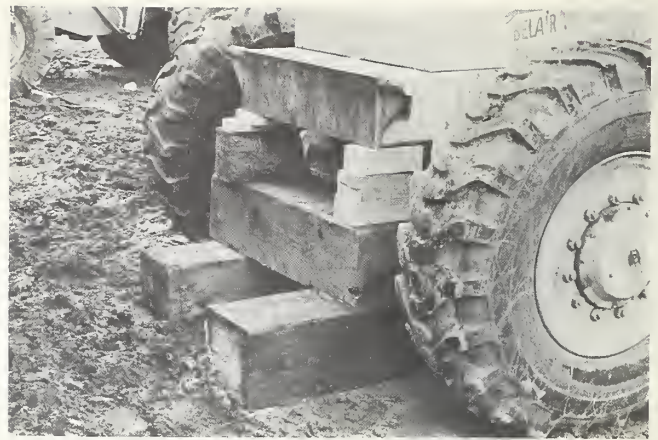
FIGURE 4.8 Reaction block in front of forklift.

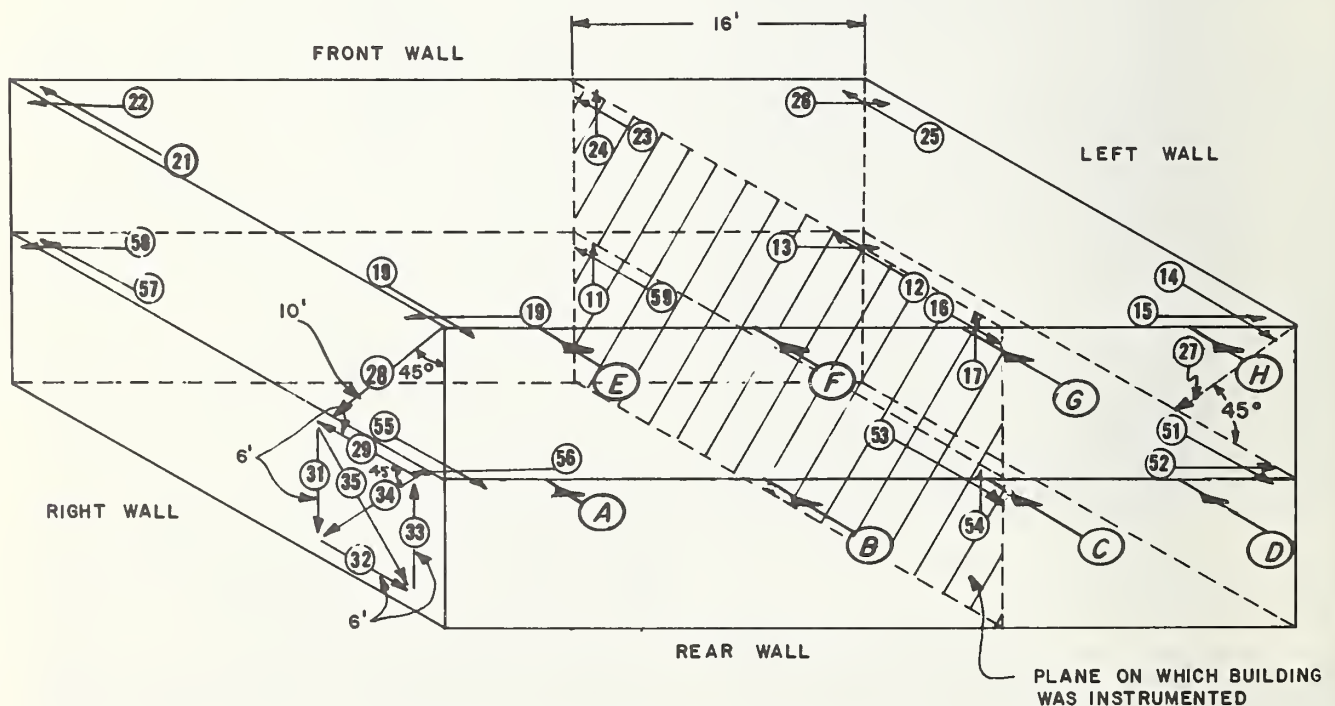
ALL LVDT'S NEAR THE SIDE WALLS, EXCEPT THE LVDT'S AT THE CENTER VERTICAL PLANE, WERE SET 5.5" BELOW THE CEILING AND 9" AWAY FROM THE WALL.

FIGURE 4.9 Location of transducers and loading points.

The location of the transducers is shown in figure 4.9 wherein the circled numbers identify each displacement transducer. The arrows show the displacement vectors measured. Points of load application are identified by letters. The letters and numbers shown in figure 4.9 are used throughout this report to designate the locations of loads and displacements. Instruments were installed near the corners of the building and in the plane, shown cross-hatched, which is parallel to the side walls and located 16 ft from the exterior face of the left side foundation wall. The location of the measurement points relative to the interior wall and ceiling surfaces is noted in the figure. It also can be seen that the rear part of the right side wall in the lower story was instrumented to measure racking distortion. Similar measurements were made on the rear part of the right and left side walls in the upper story by instrumenting a single diagonal.

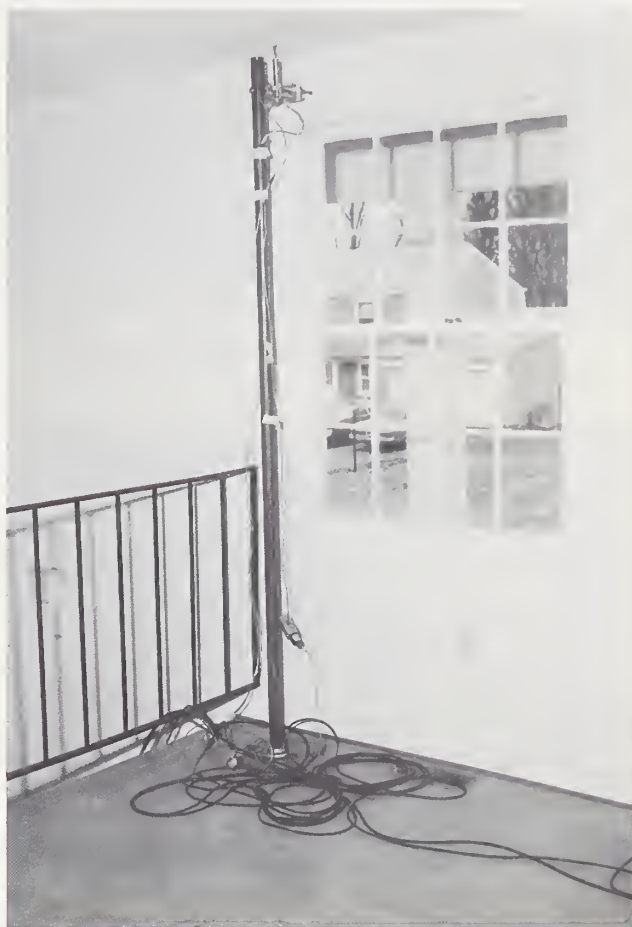
FIGURE 4.10 *Transducer stand.*

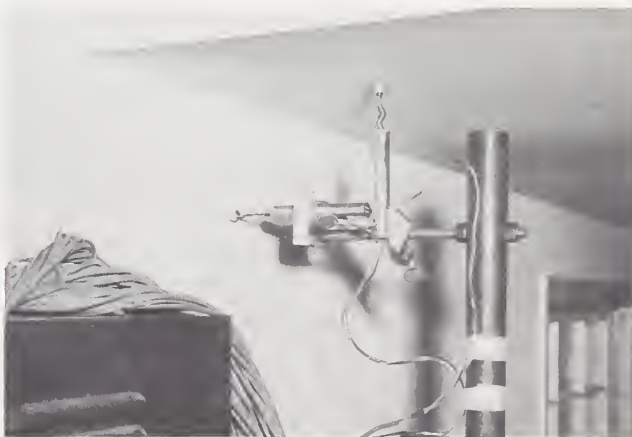
FIGURE 4.11 *Displacement transducers.*

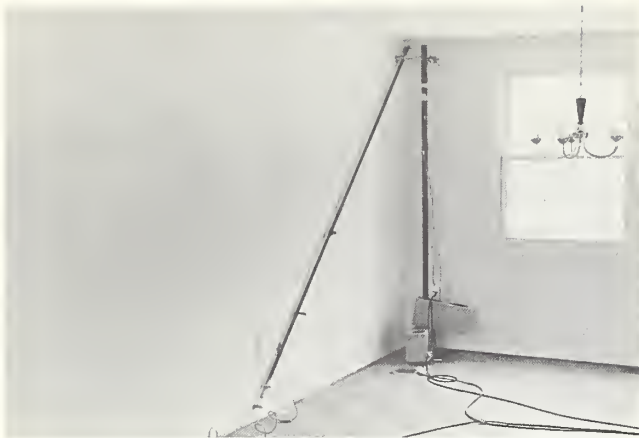
FIGURE 4.12 Instrumentation of wall diagonal.

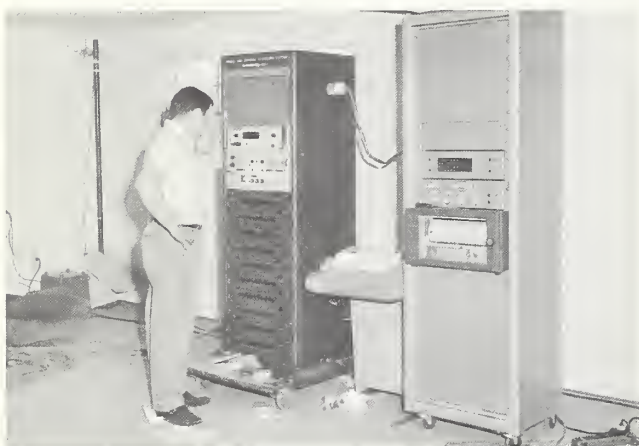
FIGURE 4.13 Data logging system.

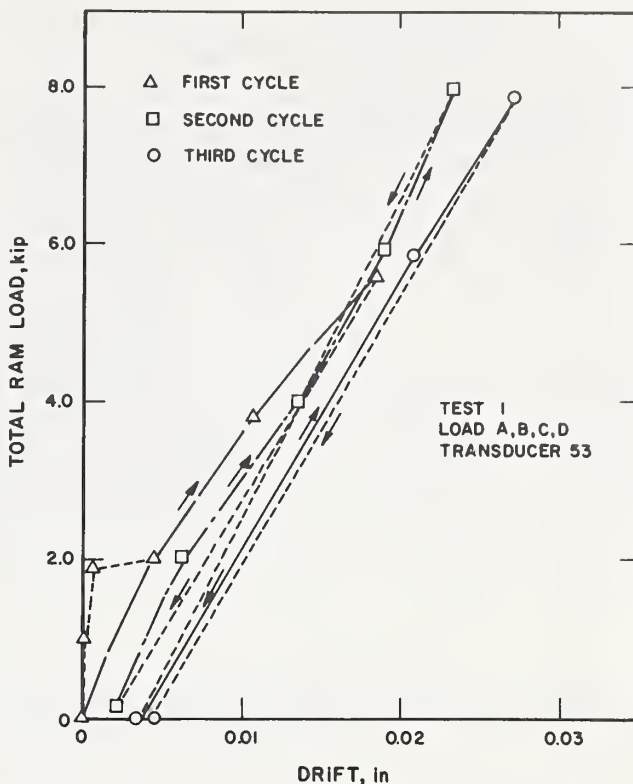
FIGURE 6.1 Response to lateral load in Test 1.

Figure 6.1 shows a plot of total horizontal load against drift, measured at transducer 53, which was located at the lower-ceiling level near the point of largest displacement. The plot is for Test 1, in which three cycles of load were applied. In the unloaded position after the first loading cycle, the residual drift displacement was 0.002 in. This was approximately 12 percent of the drift due to the maximum load applied in this cycle. Subsequent increments of residual deflection were smaller, indicating that residual deflection was reduced by reduction of slackness in the system and possibly by response characteristics similar to strain hardening.

The total residual displacement in this test was 0.004 in, which is approximately 15 percent of the maximum displacement observed in this test (0.027 in).

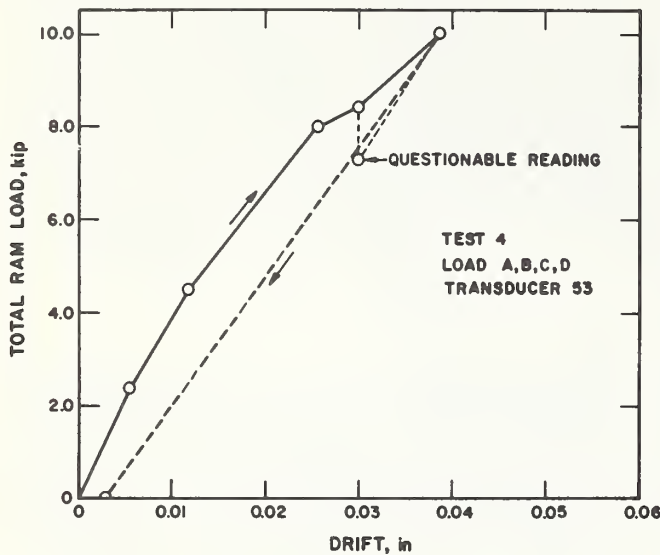
FIGURE 6.2 Response to lateral load in Test 4.

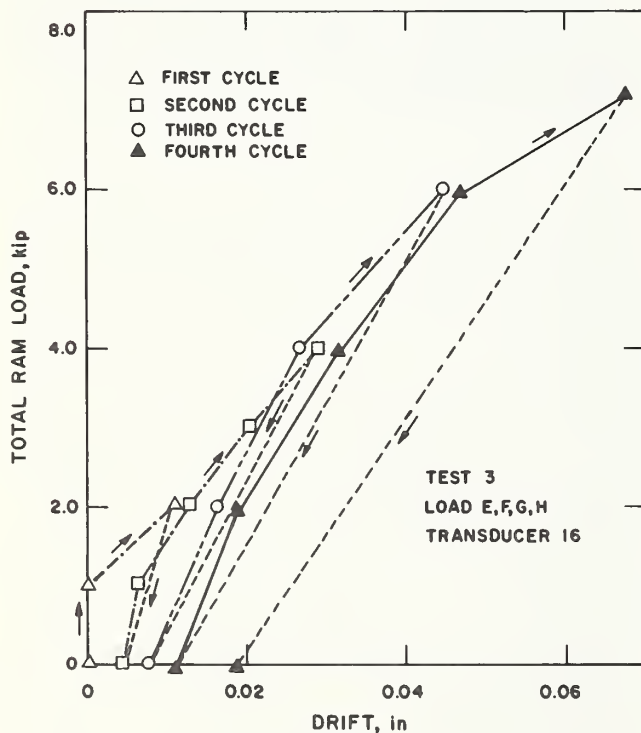
FIGURE 6.3 Response to lateral load in Test 3.

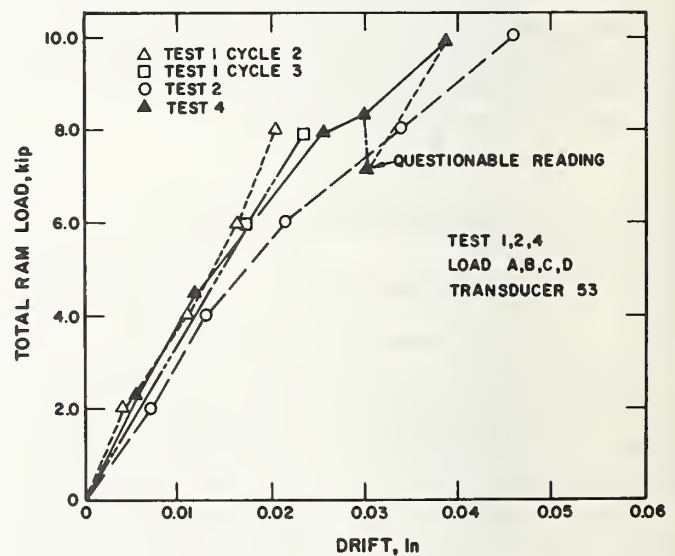
FIGURE 6.4 Reproducibility of structural response to lower-level loading.

Reproducibility of data is illustrated in figures 6.4 and 6.5. Figure 6.4 shows a plot of displacement at point 53 against lower-level loading for cycles 2 and 3 in Tests 1, 2, and 4. Data from all these four tests are reasonably consistent. Similarly, figure 6.5 shows displacements at transducer 16 for cycles 2 and 3 of Test 3, which are in good agreement. Similar trends were observed for other transducers measuring displacement

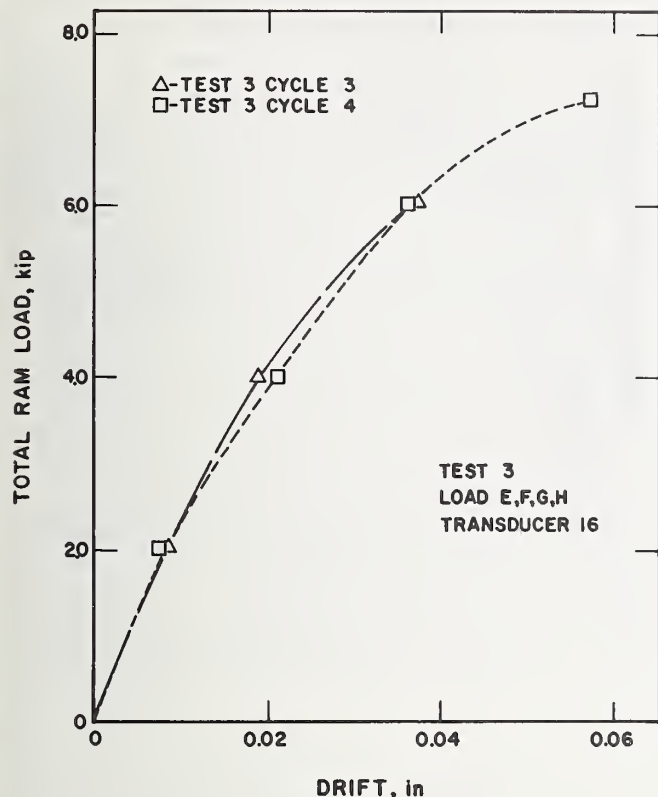
FIGURE 6.5 Reproducibility of structural response to upper-level loading.

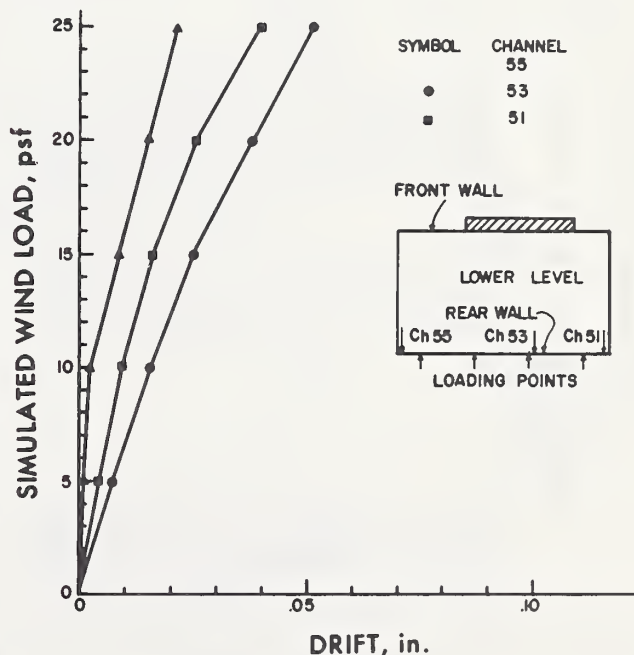
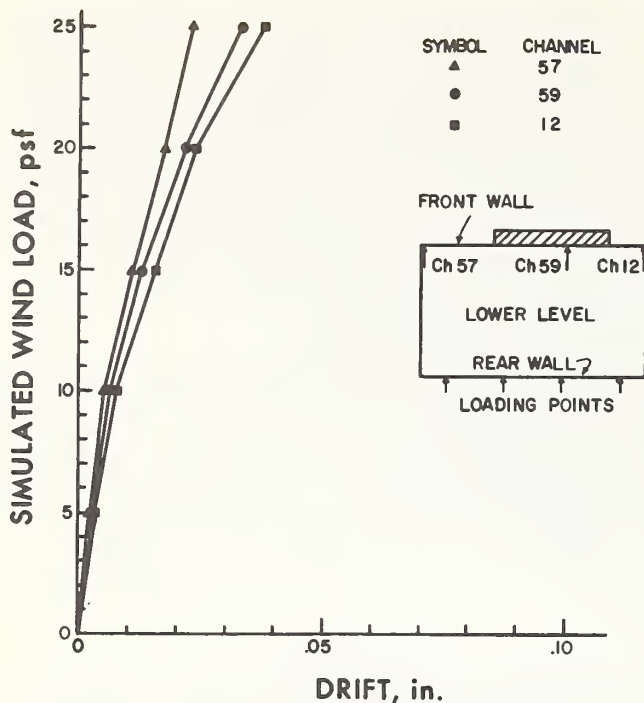
FIGURE 6.6 Drift at upper-floor level.

FIGURE 6.7 Drift at upper-floor level.

Figures 6.6 through 6.9 show drift versus wind load for all the points where drift in the direction of the applied load was measured. The figures were derived by superimposing displacements caused by lower-level loading measured in Test 2 and displacement caused by upper-level loading equal to the average of the measurements in the second and third cycles in Test 3.

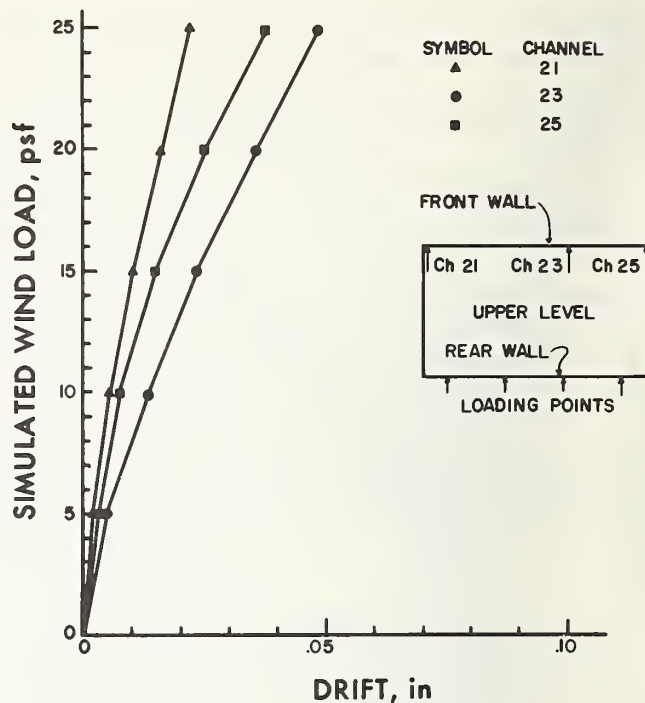
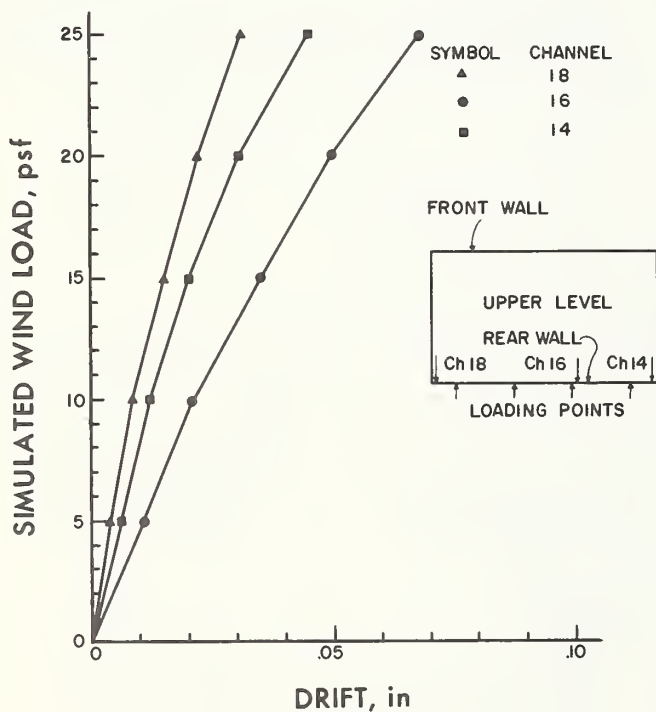
FIGURE 6.9 Drift at upper-ceiling level.

FIGURE 6.8 Drift at upper-ceiling level.

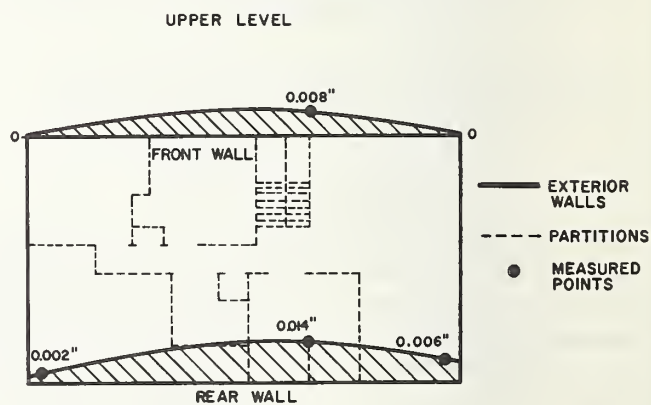
FIGURE 6.10 Displacement of upper ceiling relative to upper floor under upper-level loading, simulating 15 psf wind load.

The figure shows significant in-plane deformation of the upper-ceiling diaphragm. At the upper rear corners, the exterior side walls moved in the direction of the applied load; however, no translation was observed at the two front corners. The framing of these walls provides let-in bracing from each rear upper corner, at a 45° angle to the vertical, down to the upper-floor level.

Figure 6.10 shows the displacement at the upper-ceiling level relative to the surface of the upper floor. This drift was measured in the last loading cycle of Test 3, for which lateral load was applied at the upper-ceiling level. Drift was derived for a total ram load of 2.82 kip which simulates approximately the contribution of the wind load to the upper-ceiling level when a total wind load of 15 psf acts normal to the long walls of the building.

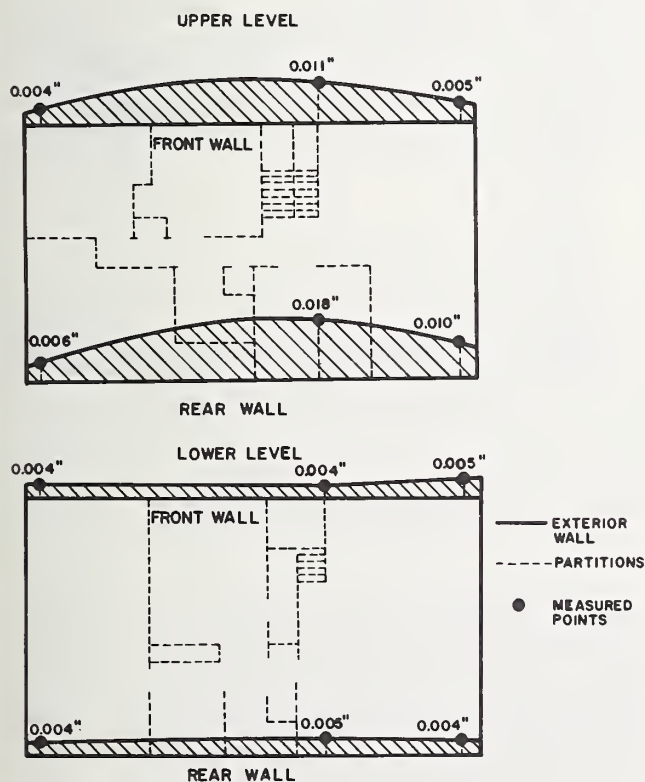
FIGURE 6.11 Total drift under upper-level loading simulating 15 psf wind load.

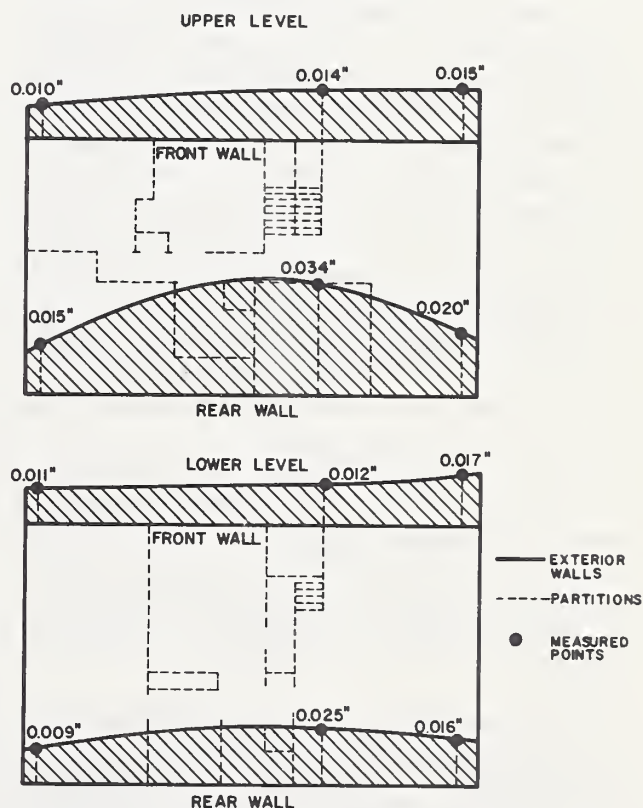
FIGURE 6.12 Drift under combined upper- and lower-level loading simulating 15 psf wind load.

Figure 6.12 shows drift at the upper- and lower-ceiling levels under a simulated wind load of 15 psf normal to the long walls. The translations shown in the figure were computed by superposition, adding translations caused by applying ram loads at the upper-ceiling level (last loading cycle, Test 3) to those caused by ram loads applied at the lower-ceiling level (Test 2). Wind pressures corresponding to the ram load were computed as in section 6.2. The building as a whole translated and rotated slightly. The rotation is probably attributable to the unsymmetrical distribution of interior partitions and is an order of magnitude smaller than the overall drift deformations. Even though the drift near the center of the building at the lower-ceiling level was greater than that at the side walls on the same level, it cannot be concluded that this difference is attributable to overall in-plane deformation of the floor-ceiling assembly, since the translation near the front wall on the same level corresponds approximately to a rigid body displacement.

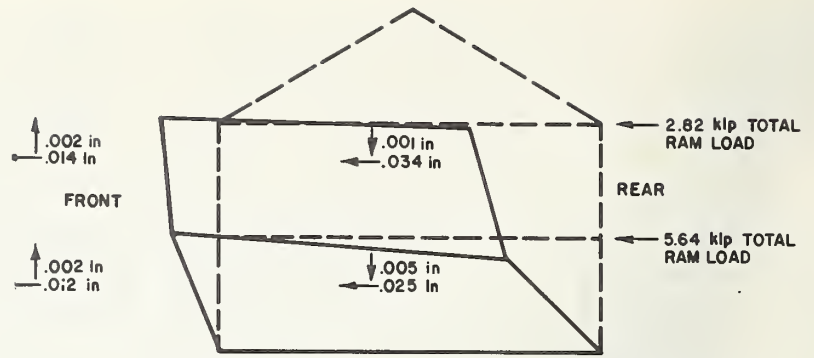
FIGURE 6.13 Lateral and vertical displacements near the center of the building (refer to fig. 4.9 for location of measurements).

Figure 6.13 shows lateral and vertical displacements near the center of the building (refer to fig. 4.9 for the position of displacement measurements), caused by a simulated 15 psf wind load. In general, the vertical displacements were one order of magnitude smaller than the horizontal displacements. As a result, no significant conclusions can be drawn from the vertical measurements.

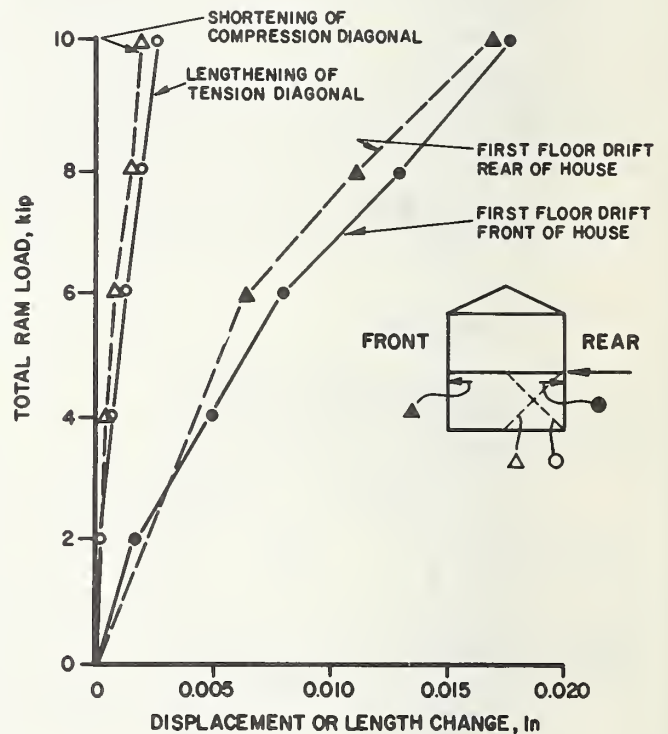
FIGURE 6.14 Wall distortion.

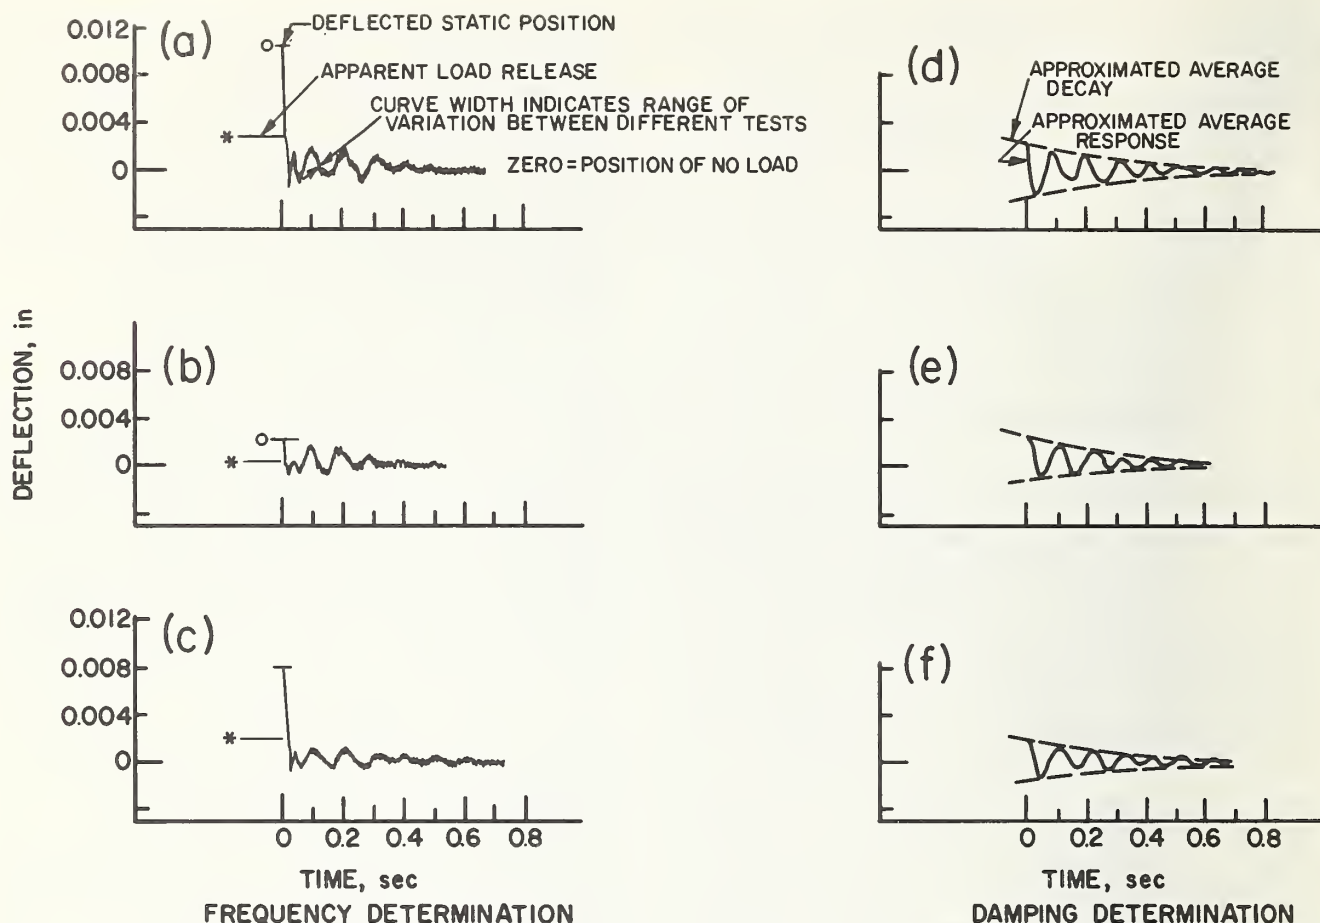
FIGURE 6.15 Dynamic response characteristics.

Analysis of the superimposed records shown in the plots in figure 6.15(a), (b), and (c) shows a high frequency caused by electrical noise and a lower dominating frequency of approximately 9 Hz. Frequencies derived from these plots are reasonably consistent with each other. The frequency of 9 Hz appears reasonable for a structure of this type. The plots on the right side of figures 6.15(a), (b), and (c) show average deflection response and estimated envelopes of deflection decay from which the percentage of critical damping was computed by the following equations:

Damping computed from the plots in figures 6.15(d), (e), and (f) averages 6 percent of critical damping with an approximate range from 4 to 9 percent. Damping ratios would probably increase for vibrations with larger displacement amplitude.

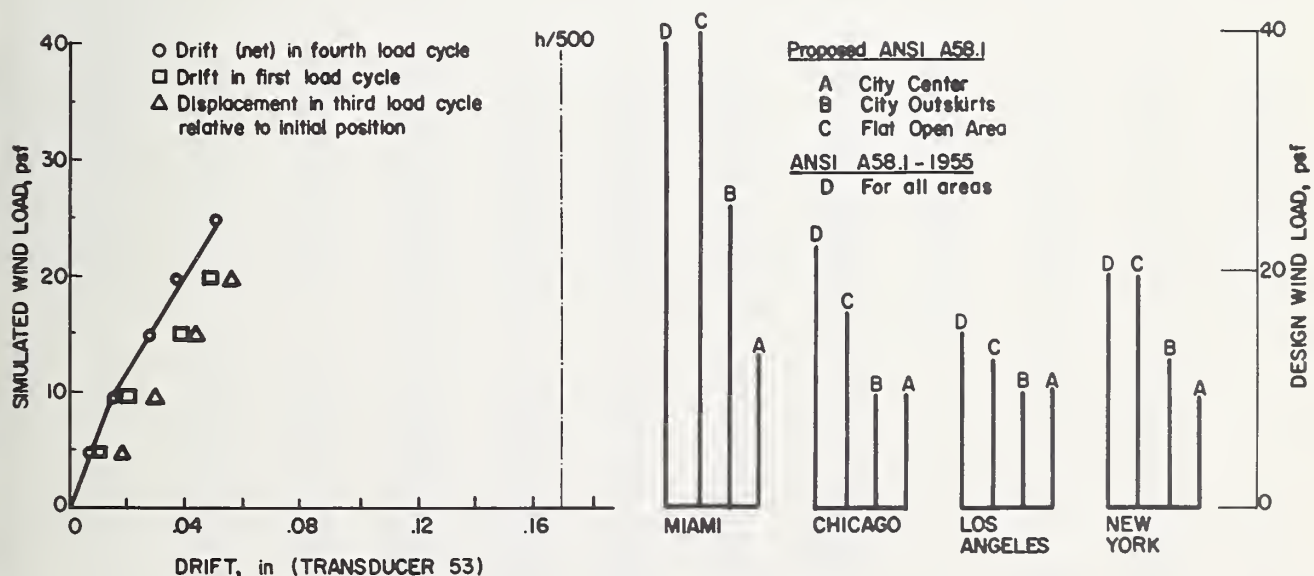
FIGURE 6.16 Comparison of measured building response with design criteria for medium- and high-rise buildings.

Figure 6.16 shows a plot of drift at the lower-ceiling level against simulated wind pressure normal to the long wall. The solid line connecting the points designated by circles shows the drift measured in the fourth loading cycle and was derived by superposition of the results of Test 2 and the last loading cycle of Test 3. Drift is shown for the location of the largest displacement observed at this level (gage 53). Superposition was used, as discussed in section 6.2, assuming that a wind force of the magnitude shown on the vertical scale of the plot acted normal to the entire long-wall area, and that no resultant wind pressure acted on the projected roof area.

To the right of the plot, wind loads computed for various areas in the United States and for different exposure conditions are shown. Columns A, B, and C were computed using the ANSI-A.58.1 Standard now proposed for adoption. Columns D were computed using ANSI Standard A.58.1-1955 which is presently in force and which does not distinguish between various exposure conditions. Note that, except for the Miami, Fla. region, the measured drift of this building, after slackness in the system was removed in three preloading cycles, is considerably less than that derived using present design criteria for medium- and high-rise buildings. No conclusion can be drawn for Miami, since the design wind loads required for this region exceed the loads actually applied in the test.

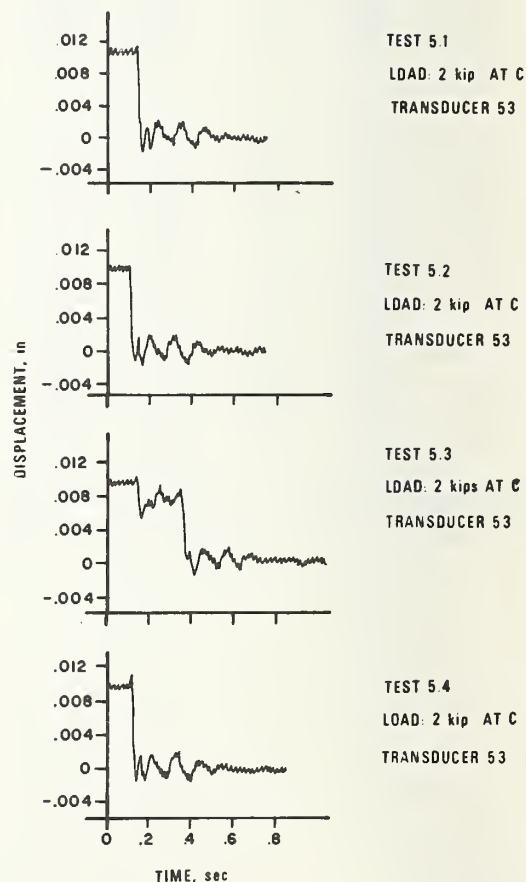
FIGURE A.1 Oscillograms of Tests 5.1-5.4.

Oscillograms for Tests 5.1, 5.2, 5.3, and 5.4 are shown in figure A.1. Figure A.2 shows Tests 5.5, 5.6, and 5.7. Tests 5.8 and 5.9 are shown in figure A.3.

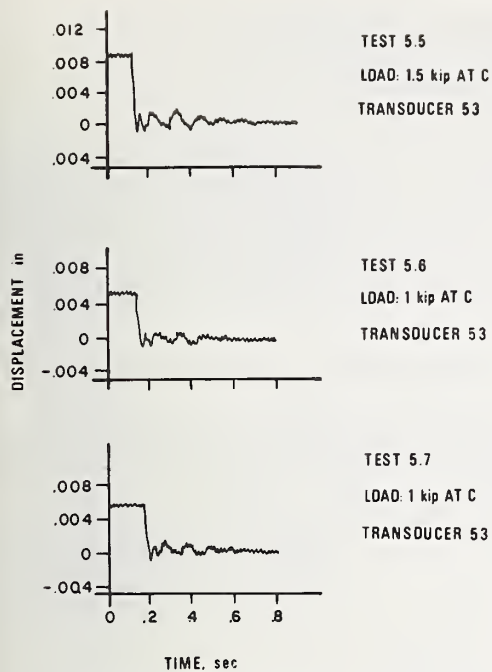
FIGURE A.2 Oscillograms of Tests 5.5-5.7.

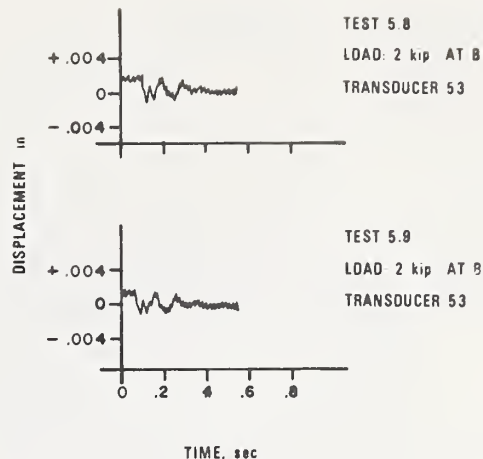
FIGURE A.3 Oscillograms of Tests 5.8 and 5.9.
